Title: Product weathertightness testing of a sliding rooflight sample for Vision AGI

Report No: N950-19-17694

Customer: Vision AGI
Queens Business Park
Wilbraham Road, Fulbourne, Cambridge CB21 5GT

Issue date: 8 May 2019

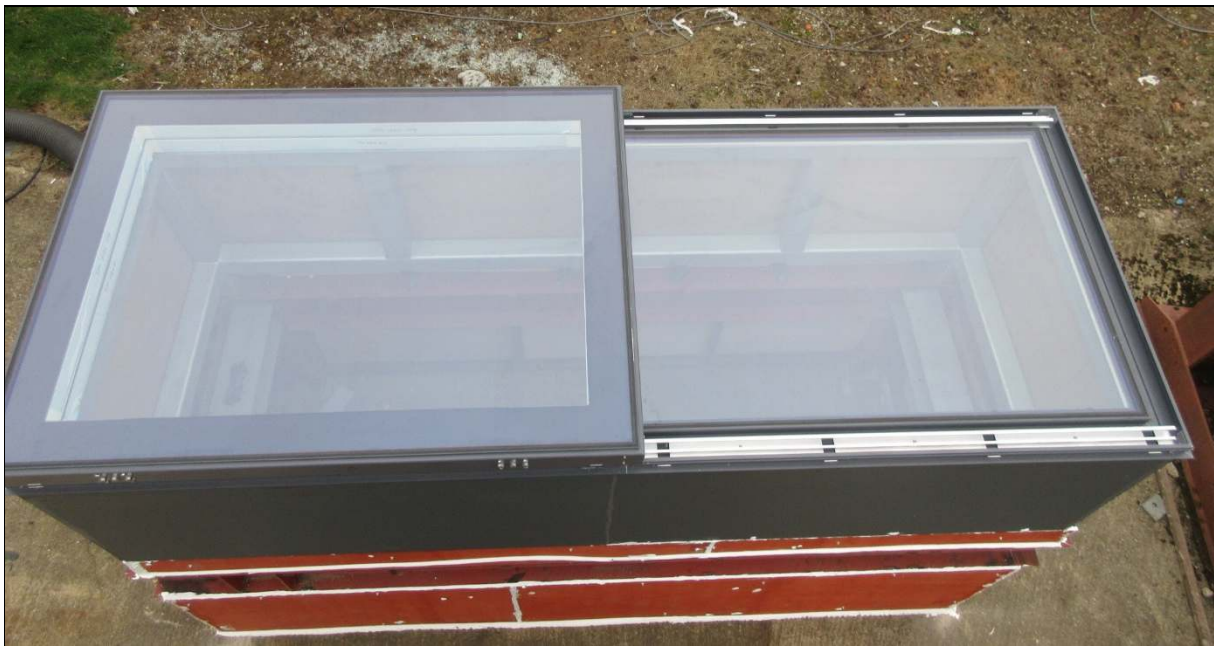
PHOTO 1411

The sample was as shown in the photo below and the drawing included as an appendix to this report.

TEST SAMPLE

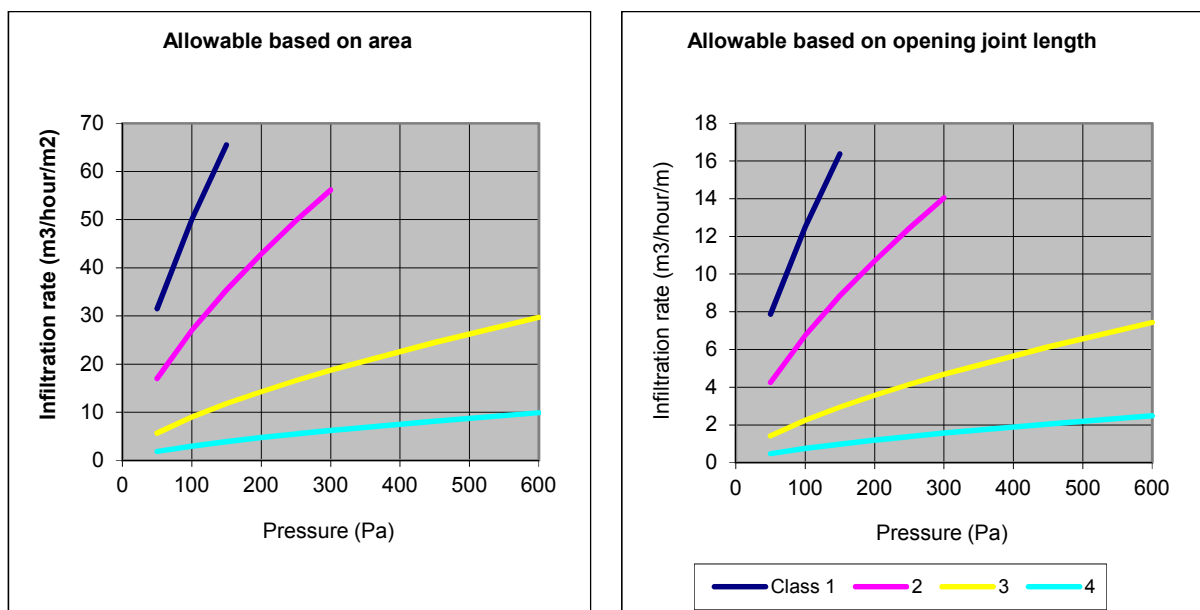
FIGURE 2

At intermediate pressures, p_n , flow rates, Q_n , shall be calculated using $Q_n = Q_{100}(p_n/100)^{2/3}$ as shown in the graphs below.

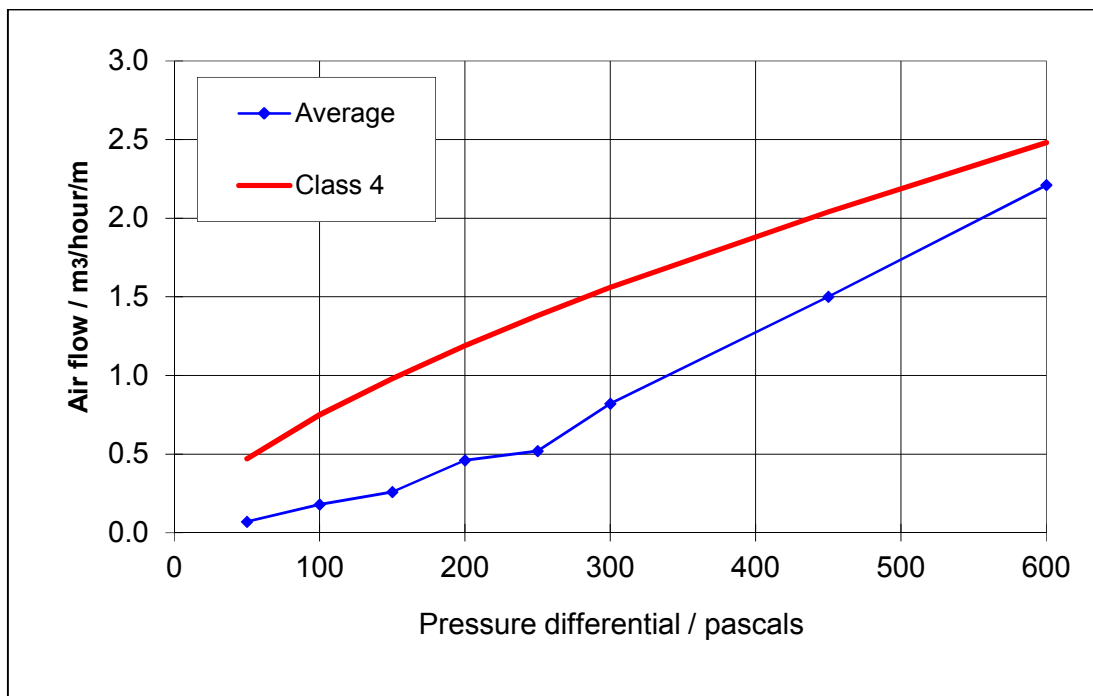
FIGURE 4

Test 1 average air permeability test results based on length of opening joint

The results are shown graphically in Figures 3 and 4.

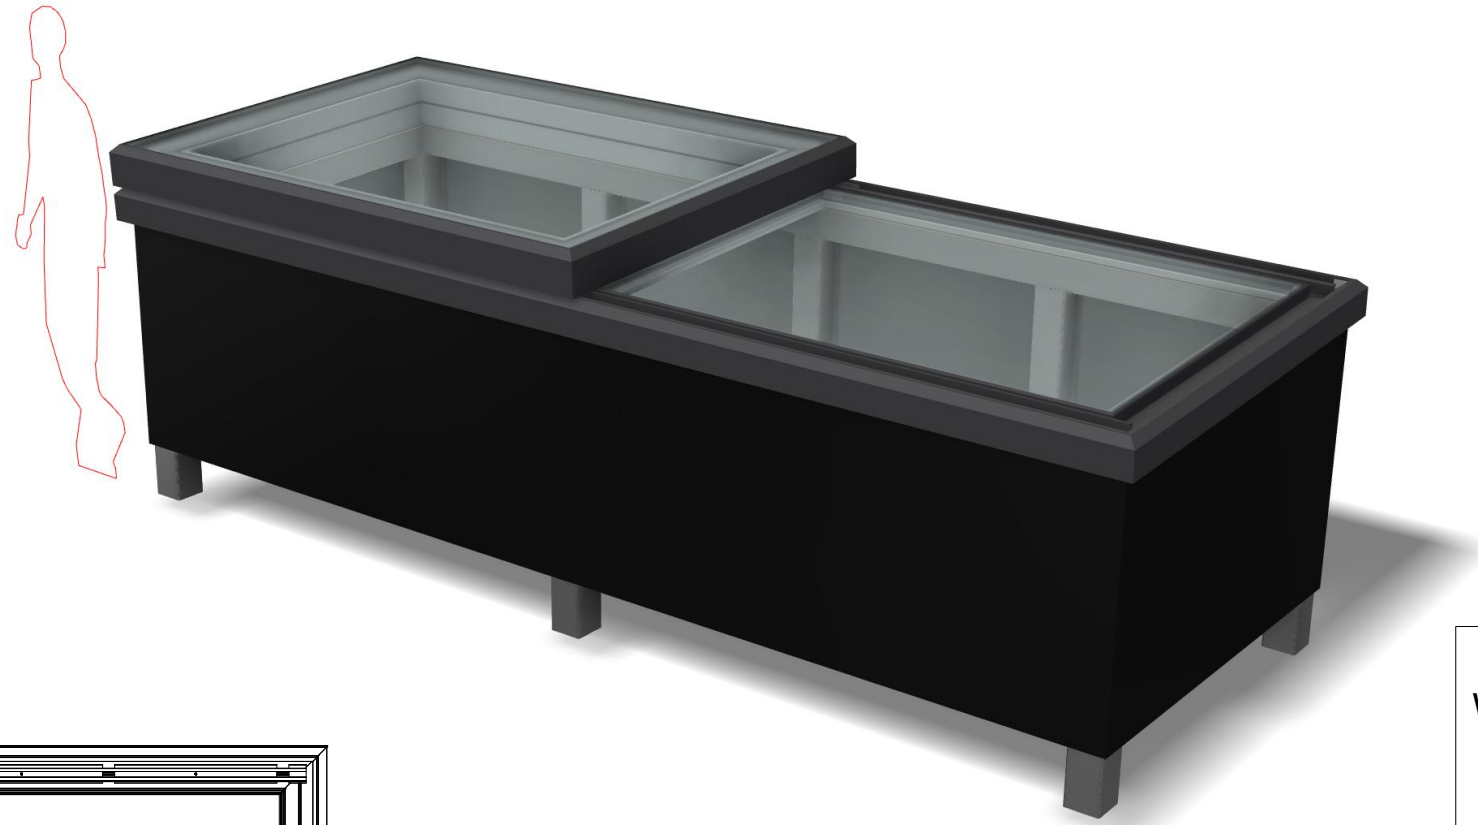
DRAWING No.	SHEET
300-VINCI-001	1 of 1

The following unnumbered page is a copy of Vision AGI drawing numbered 300-VINCI-001.

PRODUCT/PROJECT:
Sliding Over Fixed

DESCRIPTION:
Vinci Testing Drawing
